SALEM, NEW HAMPSHIRE

**WHEELER DAM
ARLINGTON MILL RESERVOIR
NH 00028**

**PHASE I INSPECTION REPORT
NATIONAL DAM INSPECTION PROGRAM**

AUGUST 1978

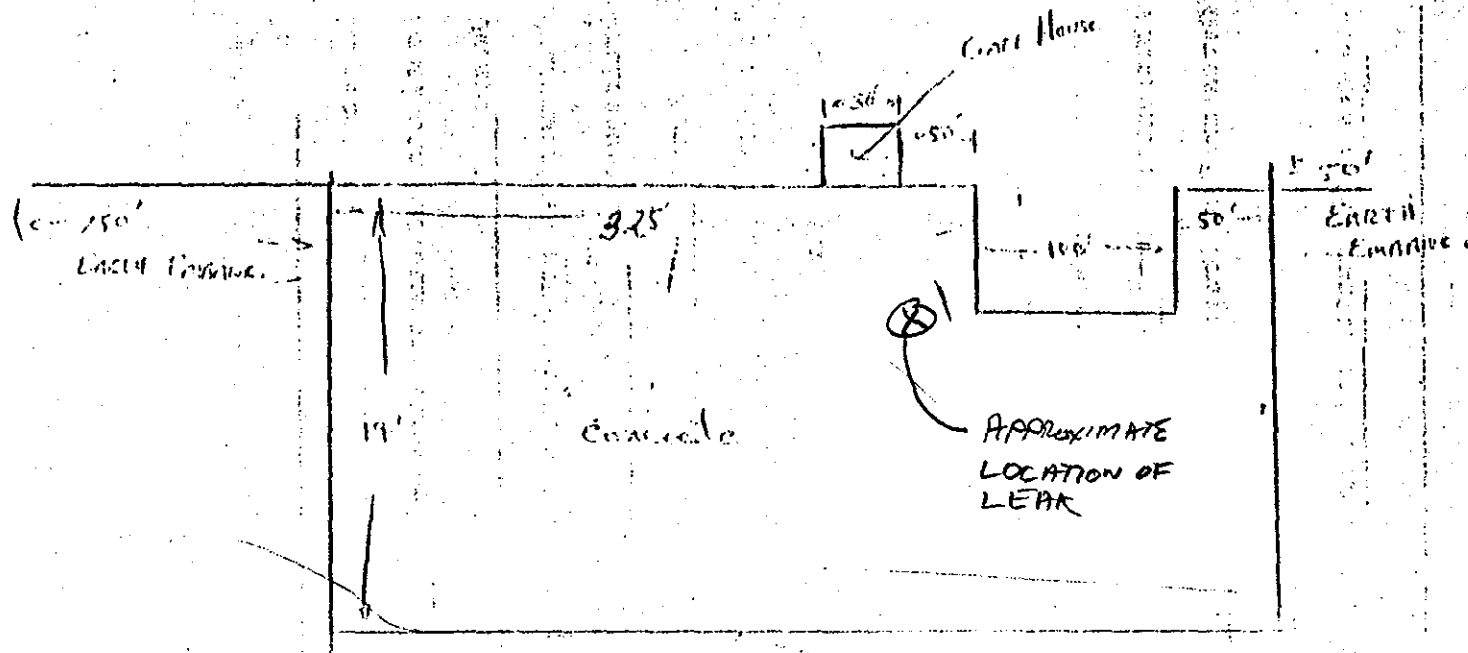
Remarks: Concrete is badly spalled around expansion joints (no change since last inspection) - taking through concrete see detail. Trees have started growing in Embankment

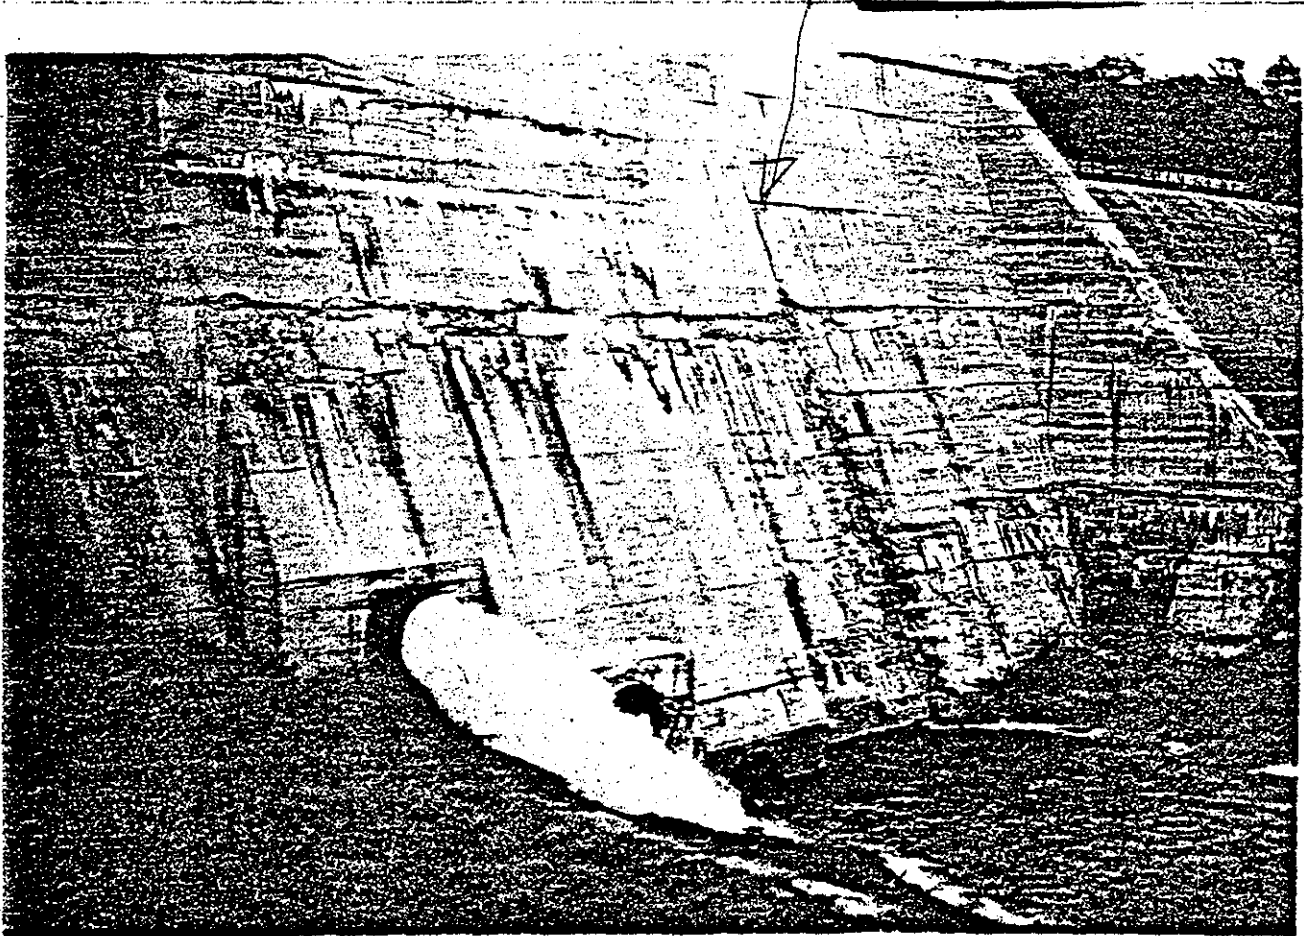
NOTE SPALLING AFTER
13 YEARS
